Water Supply Outlook

DWP-NC MOU Oversight Committee

January 7, 2023

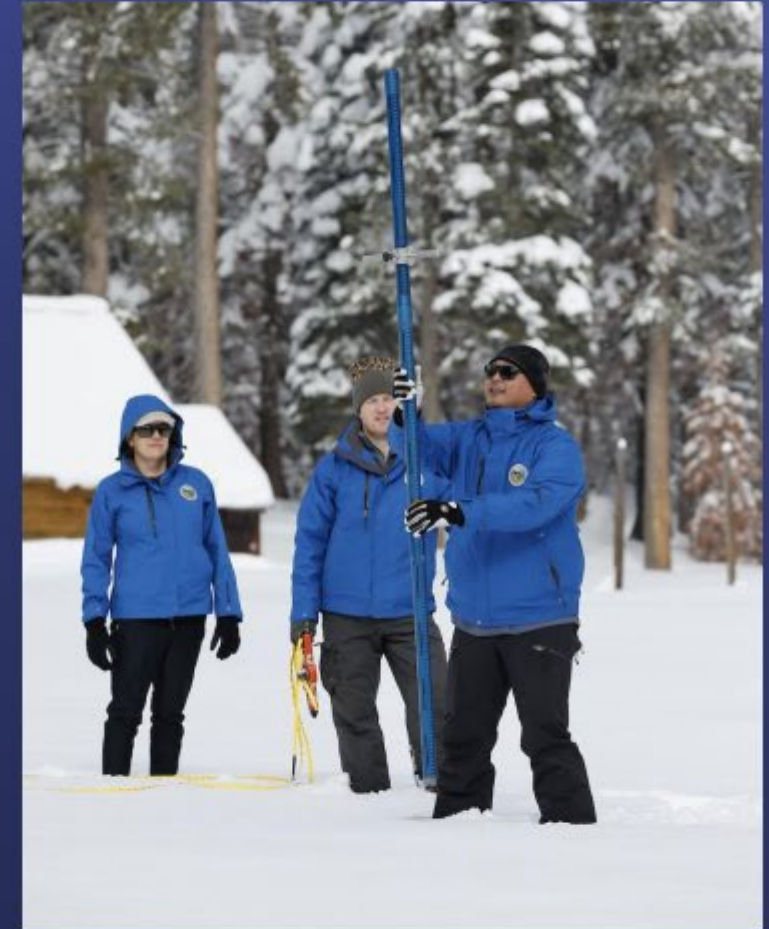
Northern Sierra Snowpack Above Normal

As of 01/05/2023

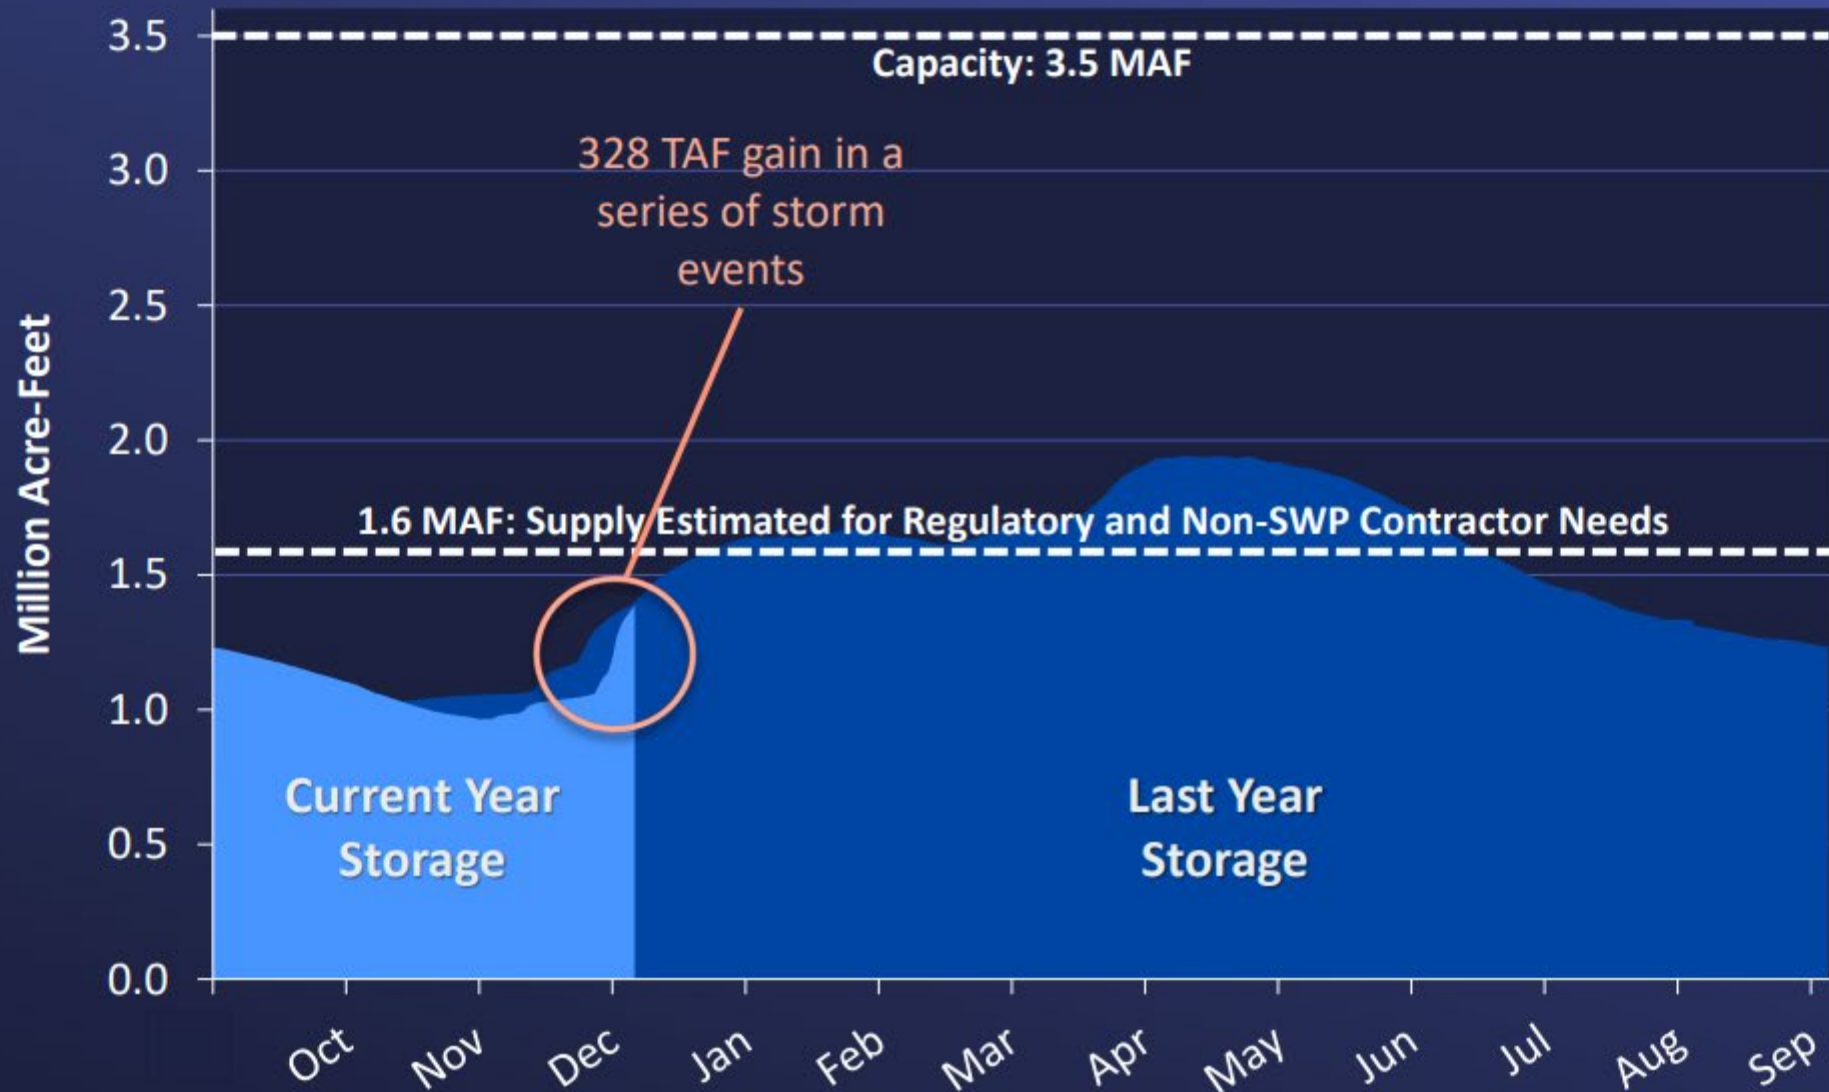
Lake Oroville Storage Levels

As of 01/04/2023

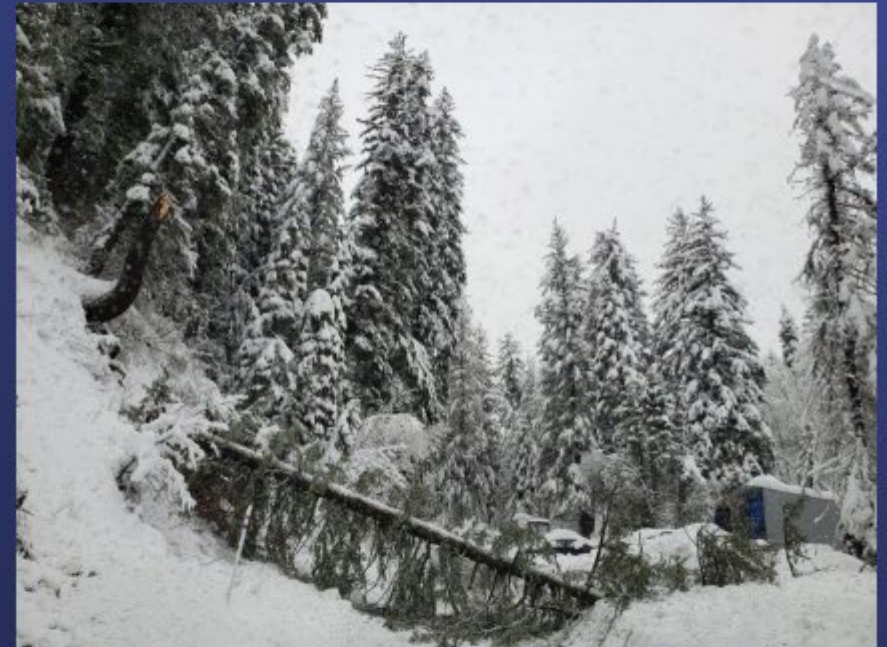
Above Normal Snowpack for Upper Colorado River Basin

As of 01/05/2023
